EXISTING EXTERIOR CONDITIONS AND ASSESSMENT REPORT
FOR

BUILDING 2 MAIN BUILDING

**CLEMENT J. ZABLOCKI
VA MEDICAL CENTER**
MILWAUKEE, WI

November 16, 2012

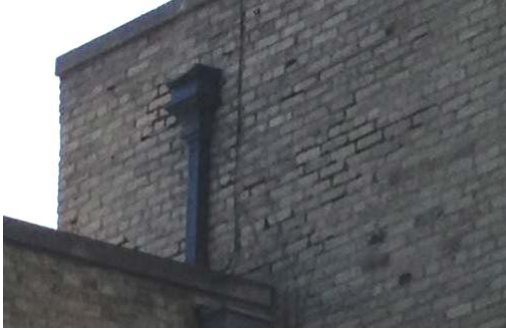
Mortar joint deterioration (north elevation of the B-Wing near west end).

Overall, the mortar joints appear to be sound, with the exception of isolated areas requiring repointing. Approximately 10% or less of the whole building exterior shell requires repointing and/or unit replacement, with the exception of the central tower of the A-Wing, which is assumed to require approximately 50-60%. Any replacement materials are to match the original in all aspects; material composition, color, texture, and compressive strengths.

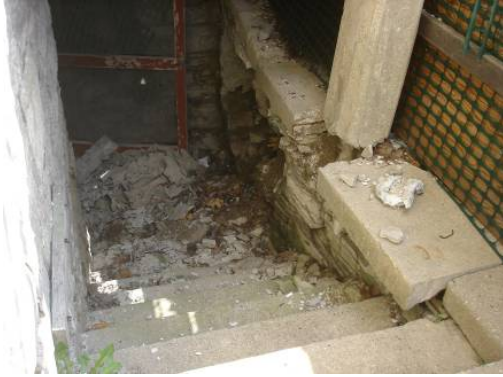
Masonry retaining wall deterioration at the north side of the B-Wing.

There is a masonry retaining wall at the below-grade lower level entry on the north side of the B-Wing showing severe signs of degradation. It is recommended that adjacent soils have appropriate drainage so as not to hold moisture, thus preventing further freeze/thaw heave. The walls should be rebuilt with stone to match the historical appearance.

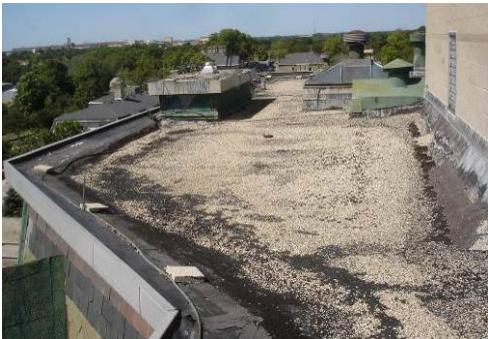
Typical poor condition of the low slope roof as seen to the south of the elevator penthouse.

The low-slope roof areas consist of built-up roof systems in extremely poor condition, and the base flashings at the perimeters are in particularly poor condition. It is likely that these materials contain asbestos and should be tested as part of the roof design.

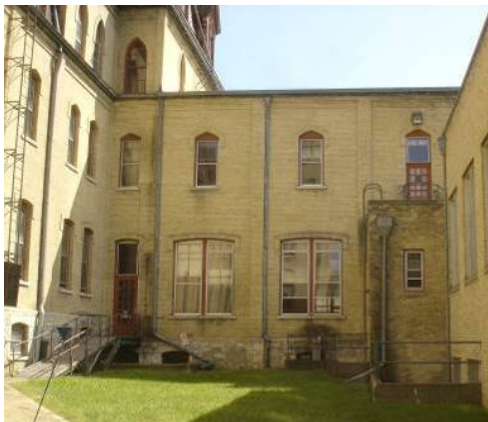
Gutters, scuppers and downspouts either drain directly at grade or into a below grade piping system.

All of the drainage for the building is handled by exterior gutters, scuppers, and downspouts. Some downspouts drain directly on the ground a few feet from the building, and others tie into a below-grade piping system. Many of these older below-grade drainage systems were tied into the sanitary water system, which may or may not still be the case. It is recommended that the entire roof drainage system be designed to carry water immediately away from the building. Where drains are underground, they should be tested to make sure they are open, free flowing, not connected to the sanitary sewer system, and not allowing water to enter the building basements.

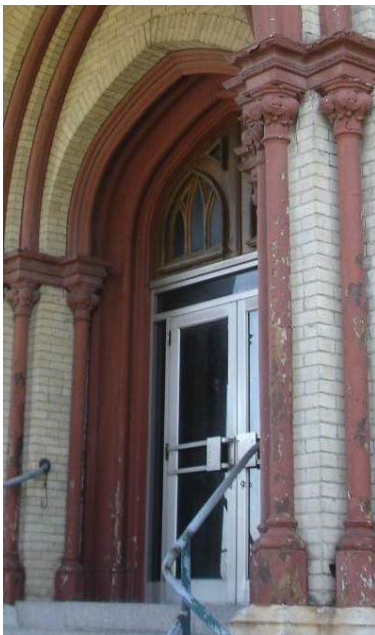
Non-historic aluminum storefront system.

The aluminum storefront system at the main front (east) entry is not original and is assumed to have been wood originally. It is recommended that additional research be performed to determine the original appearance and to restore it.

The aluminum storefront systems at both the north and south ends of the A-Wing are not character defining historical features. They should be removed and replaced with more energy efficient contemporary systems, the original entrances could be restored, or more historically compatible additions could be considered.

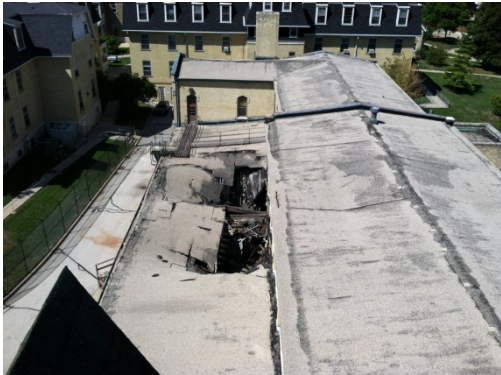
Collapsed roof area at the B-Wing.

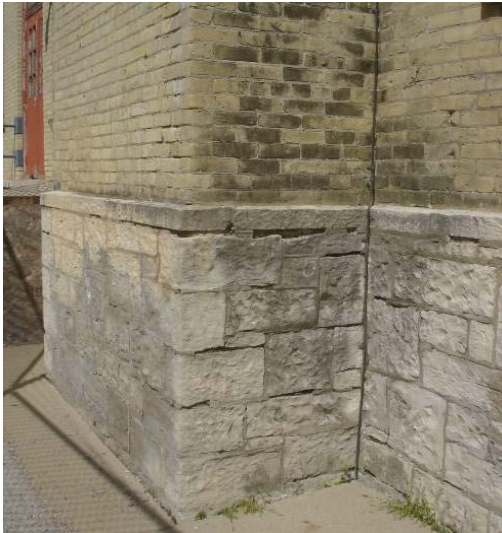
Surface staining and mortar joint deterioration of stone and brick joints at an inside corner of the B-wing. There is also minor stone edge erosion where mortar has deteriorated.

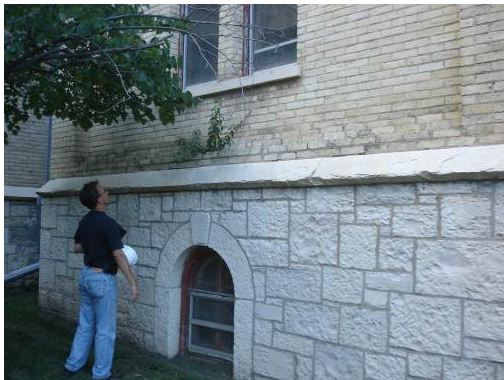
Biological growth at brick corbelling.

For masonry areas that require cleaning, it is recommended they be cleaned with the gentlest means possible, starting with a mild detergent and progressing up to a diluted acidic wash. For areas with biological growth, it is recommended that all growth be removed prior to cleaning.

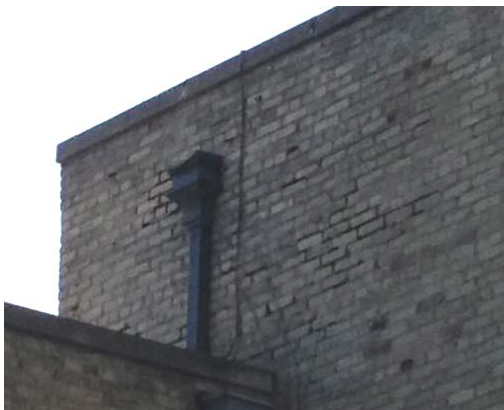
Mortar joint deterioration (north elevation of the B-Wing near west end).

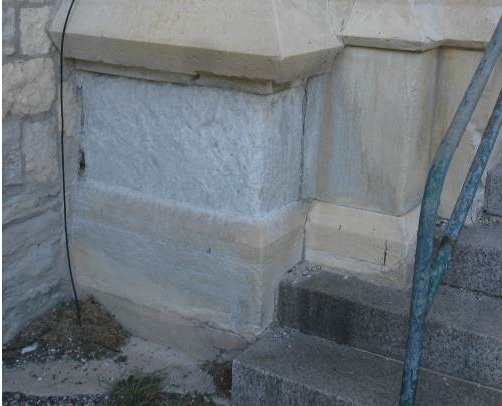
Spalling stone at the main entry on the east elevation.

There is stone deterioration around the building including surface degradation and spalling, cracking, and displaced or missing stone. It is recommended that the stone be repaired or replaced as required. It is also recommended that the future use of de-icing salts be restricted from being used adjacent to masonry surfaces. Other areas of surface degradation are likely caused by water run-off. The sources should be determined and corrected prior to masonry restoration.

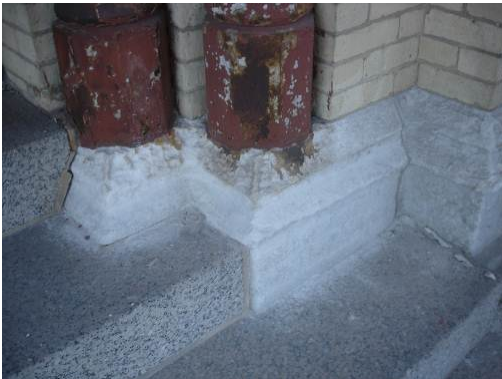
Spalling stone at the north side of the main entry stairs on the east elevation.

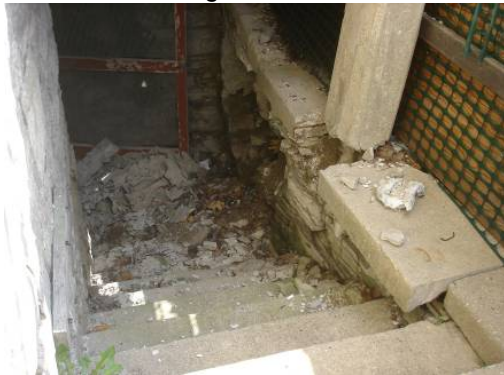
Masonry retaining wall deterioration at the north side of the B-Wing.

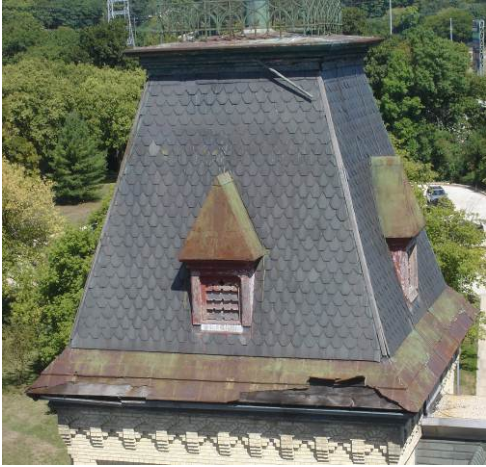
The northwest corner tower reroofed with a single color with finish failure of the terne coated metal and significant deterioration of the metal at the base.

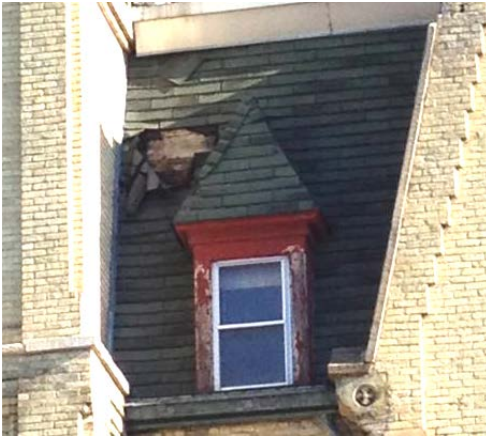
Asphalt shingle deterioration at the south elevation is exposing the wood roof decking below.

- **Roofs**
 - 100% Slate shingle replacement with slate (or simulated slate) shingles.
 - 100% asphalt shingle replacement with slate (or simulated slate) shingles.

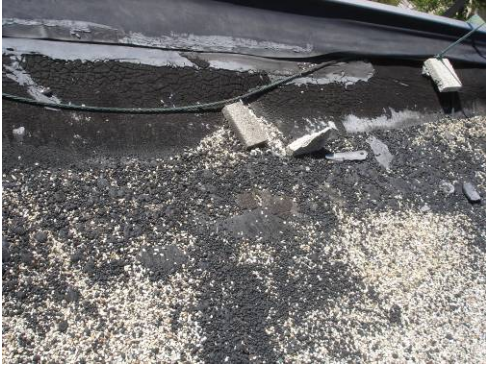
The low-slope roof areas consist of built-up roof systems. These roofs are in extremely poor condition and have surpassed their intended life expectancies. There are areas where “blisters” have formed and the built-up membrane is no longer sufficiently adhered to the roof deck. There is also visible degradation of the membrane at the roof perimeter where the aggregate surfacing has been redistributed by weathering.

Typical poor condition of the rubber/tar membrane at the roof perimeter.

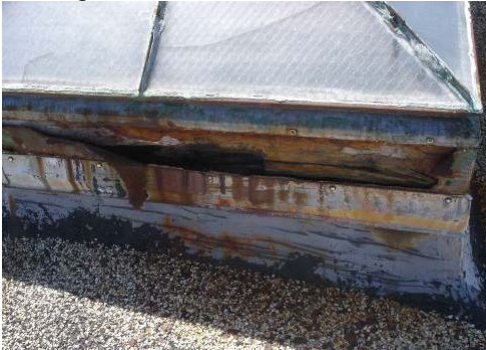
The skylights' metal framing appears to be in fair condition, while the metal counter-flashing ranges from poor to fair condition. If the skylights are to be retained when roof work proceeds, it is recommended that all of the flashing be replaced, any scale and rust be removed from the metal framing, the metal repaired as required, and refinished to match the historical appearance. An alternative to repair would be replacement. If units are damaged beyond repair, replacement in a manner consistent with the Secretary of the Interior's Standards could be an option.

Example of deteriorated counter flashing on the skylight.

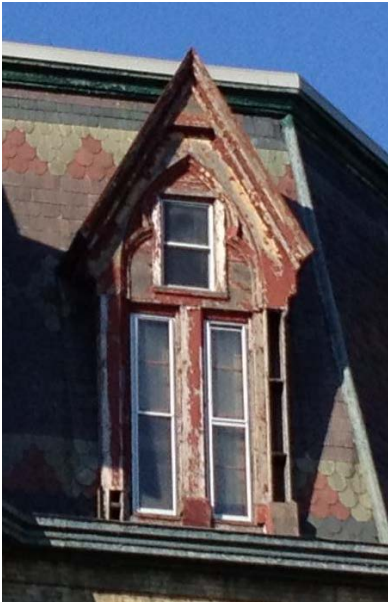
There are wood framed and trimmed dormers at the mansard roof areas of the A-Wing. Where the wood remains, the majority appears to be sound, with minor areas that may require repair. There are some areas where wood is missing.

Visible paint deterioration and missing wood trim elements at dormers.

The painted finish appears to have been a red color and has worn away from the majority of the finished wood surfaces. It is recommended that any missing or deteriorated wood be repaired or replaced, and that all of the wood surfaces be refinished to match the historical appearance.

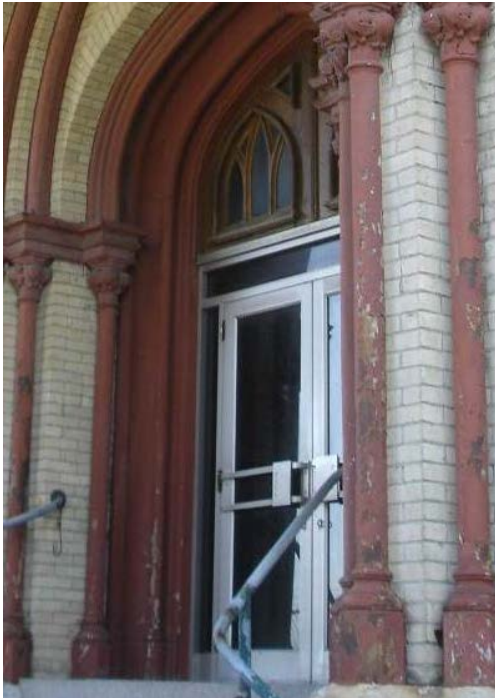
Non-historic aluminum storefront system. The original wood tracery remains in the transom window above.

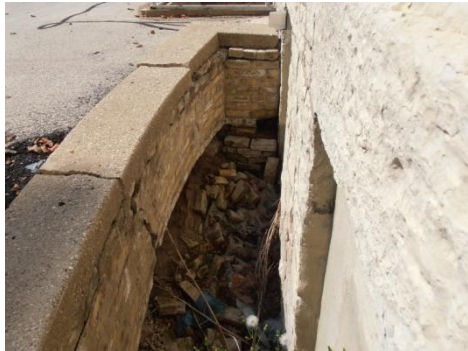
Picture #1:

The condition of area-wells around areas A, B and C of Building #2 is generally poor. Picture #1 is representative of the condition of window wells on the south face of Area B. The brick walls are cracked and failing in many locations. The concrete cap is cracked and deteriorated. The condition of foundation drainage at the bottom of the wells is unknown. The windows themselves are in poor condition and are likely allowing moisture from rain and snow to penetrate into the basement.

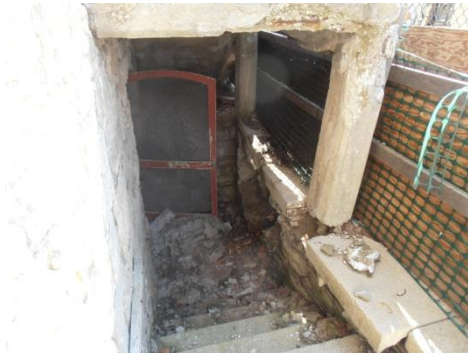
Picture #3:

Picture #3 shows the condition of an exterior stair that provides access to the basement. The stair is located at the north-west corner of Area B. There is also an upper platform that provides access to the floor above. All of the structural elements are in poor condition. It can be seen that the retaining wall has failed, as well as the concrete cap and much of the concrete structure above. This area is unusable and not safe; it should be rebuilt before the building is suitable for long-term preservation. The foundation drainage system needs to be assessed and repaired at locations like this to ensure that water is not entering the basement.

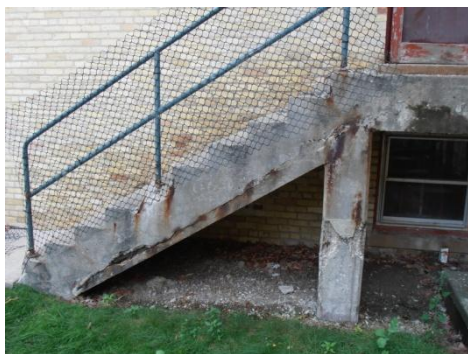
Picture #4:

Condition of other stairs around the perimeter of Building #2 is similar, though not quite as bad. Picture #4 shows a concrete stair structure located in the south-west corner of Area C. Spalling of the concrete has occurred, likely due to the deterioration of the rebar. Despite the deterioration, this stair is still safe for incidental use. Repairs aren't necessary unless the building is being considered for adaptive reuse.

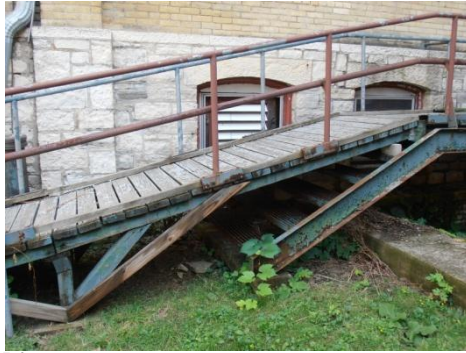
Picture #5:

Picture #5 shows a wooden ramp that was constructed over top of an existing metal access stair at the south-east corner of the courtyard between Areas A and C. The ramp may have been constructed to allow for wheelchair access to the building, as the only other ramp access that remains is located within the enclosure at the south entrance to the basement of Area A. The condition of the wooden ramp is poor. We recommend that this structure be removed prior to long-term preservation. Access requirements will certainly have to be updated per the current building code if adapt reuse takes place, and ramp requirements can be addressed at that time.

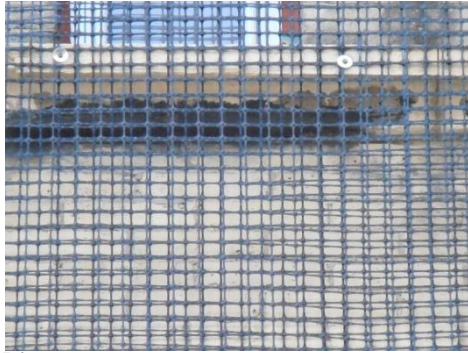
Picture #13:

Black plastic netting has been fastened to the central tower of Building #2. This can be seen in Picture #13. Date and exact purpose for installation of the netting is unknown, although we assume it was installed to protect maintenance workers and the general public from deteriorated portions of the building façade falling to the ground. The picture shows a darkened area on the sills underneath the window. Close-up examination of this condition (although in a different area) suggests the darkened area is a staining on the stone and not gross deterioration as it appears in the picture. We recommend that these areas be inspected and necessary repairs be completed to prevent deterioration from water infiltration. This should be done prior to long-term preservation.

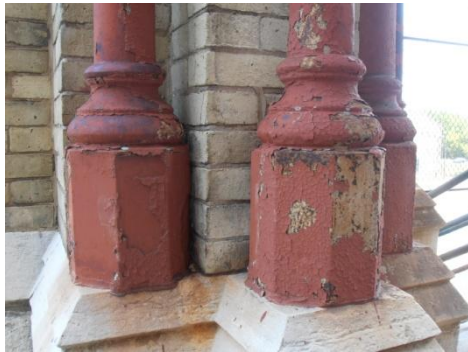
Picture #14:

Picture #14 shows the base of columns at the covered front entry. The columns, column bases and capitals all appear to be cast-iron. They are supporting incidental brick and decorative materials above; we do not think these elements are load-bearing as far as supporting the massive brick walls above. The brick arches themselves appear to provide the structural support for this purpose. The cast iron elements appear to be in good condition, except for the painted finish.

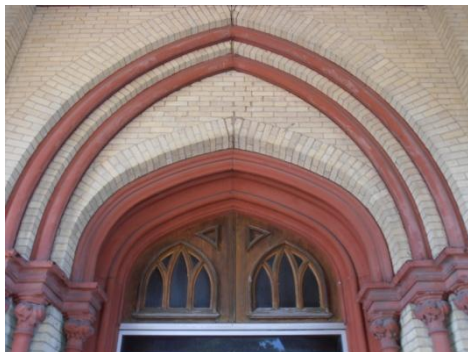
Picture #15:

Picture #15 shows decorative arches above more of the cast-iron columns and capitals. While the arches are painted the same color as the cast-iron columns, they are constructed from wood. They appear to be in good condition as they are largely protected from rain and snow under the covered porch.

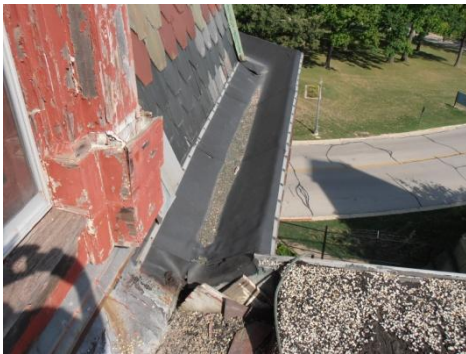
Picture #33:

Picture #33, although it is taken of a similar condition on the east side of this same roof, demonstrates the lack of proper roofing and flashing in the area where multiple sections of the roofing converge and turn down into a roof conductor.

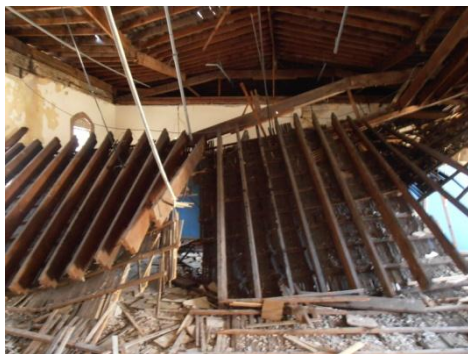
Picture #45:

This portion of the building has experienced several instances of structural collapse at both the first and second floor. These collapses were caused directly by the systemic and long term failure of the exterior building envelope, including roofing, flashing and masonry walls. This failure exposed the load carrying wood structure to gross moisture damage. Over time the wood has rotted to the point where it is no longer capable of carrying the necessary load. The result is evident in Picture #44 and Picture #45.

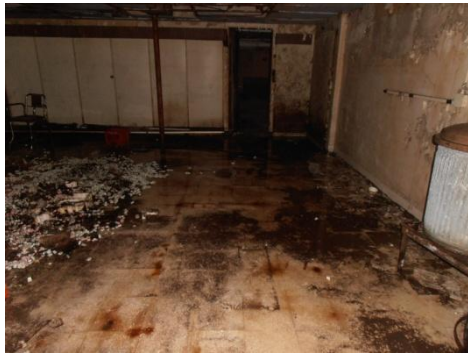
Picture #46:

It is important to note that the collapse of these portions of the roof has opened the building to further moisture damage. Picture #46 shows the pond that currently exists in the basement level below the first floor collapse as a result of water leaking through the first floor structure. It is to be expected that new damage to both the first and second floor structures beneath the collapsed areas is currently underway, but the extent of that damage cannot be evaluated until the areas of the structure open to the weather have been repaired and the building has an opportunity to dry out. At that point we recommend exploration of the structure beneath both the first and second floor collapses to determine the extent of the damage. This will involve removal of both suspended ceilings and plaster ceilings to expose the structure for observation and damage evaluation.
